SaltLess Anti Scale Media Side by Side Comparison and Field Test Results

Field Study Phase II - DESCALING

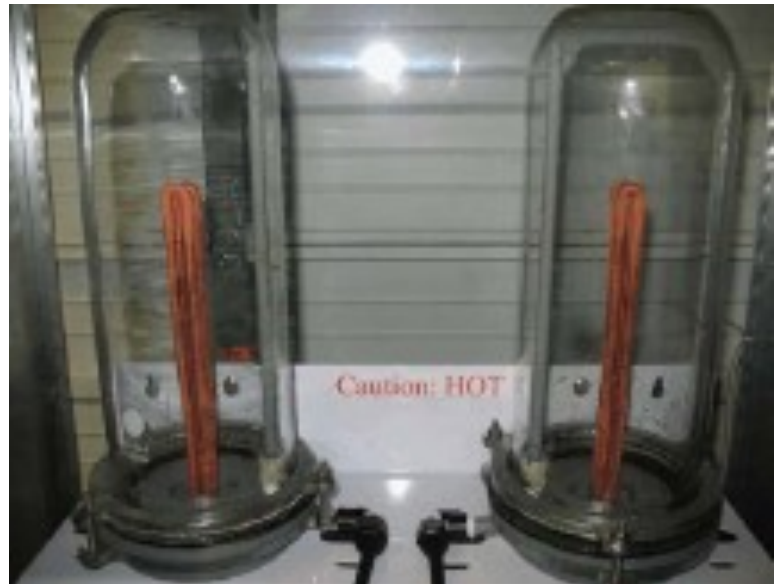
Two identical test stations were set up side by side using municipal supplied water (20 grains per gallon hardness) as the feed supply. Installed in each test station was a new electric hot water heating element.

One test station had SaltLess Anti Scale Media installed on the raw water supply and the other was simply raw municipal water with no treatment. Continuous flow through of approximately one gal/min was initiated through both test stations and both heating elements were set at 120° F. This first phase of the test was allowed to run continuously 24/7 for two weeks.

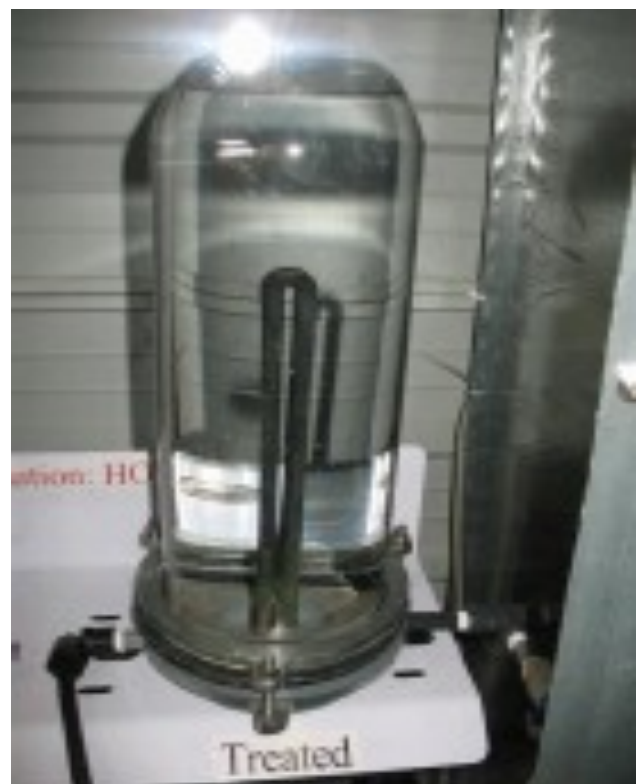
To the right is a picture of the test station using the SaltLess Anti Scale Media as treatment after two weeks of continuous water flow through.

Notice that even with 20 grains per gallon of hardness and continuous operation at 120° F, the heating element has no scale deposition.

Side by side comparison tests conclusively prove that treatment with the **SaltLess Anti Scale Media prevented hardness scale formation, even in heated water, and dissolved existing scale deposits.**

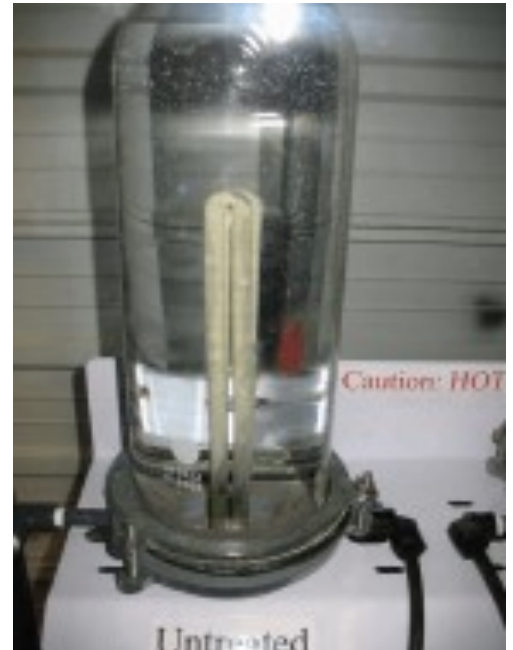
To the right is a picture of the test station with raw untreated municipal water after two weeks of continuous water flow through.

**Notice the severe
scaling effect.**

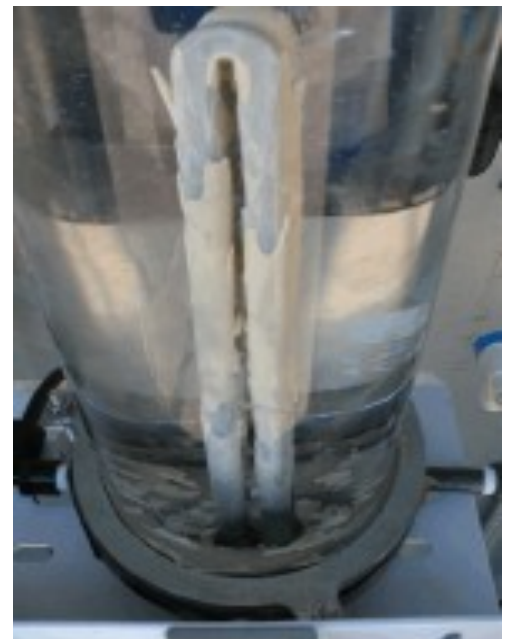
The raw water supply of the severely scaled untreated unit was treated with the SaltLess Anti Scale Media. The picture to the right depicts considerable removal of the previously deposited scale formation after only three weeks.

Notice the large scale flakes on the bottom of the test vessel.
